Hospital Linen Storage : Is It Clean ?

INTRODUCTION

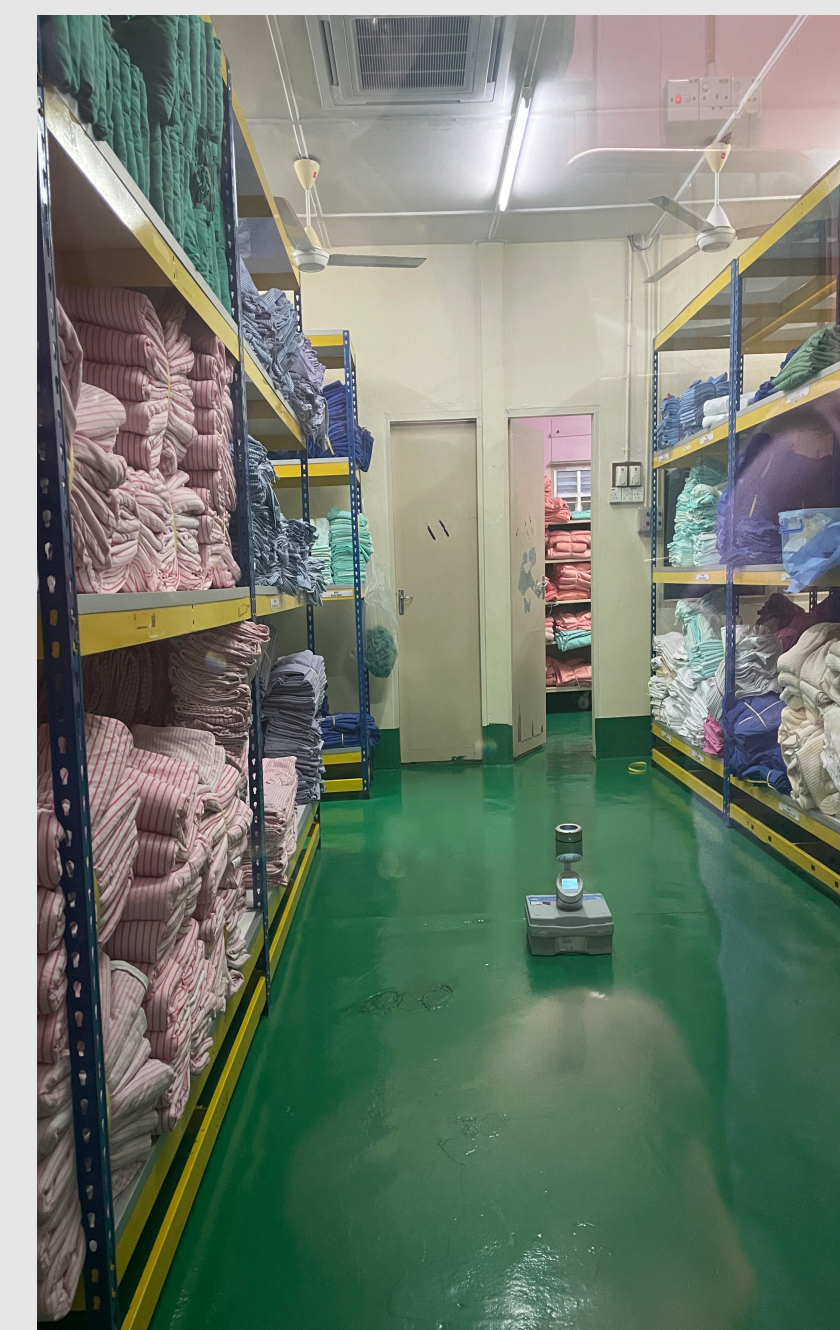
The study was started on 25th July 2023 by doing site visit at linen area. Observation at the main linen storage was carried on. Air sampling was done at inside (figure 3) and outside linen storage. Temperature and humidity were captured. Pre and post renovation surveillance sampling were done. Microbiology method was proceeded according to standard procedure.

Figure 3. Air sampling in linen store post-renovation

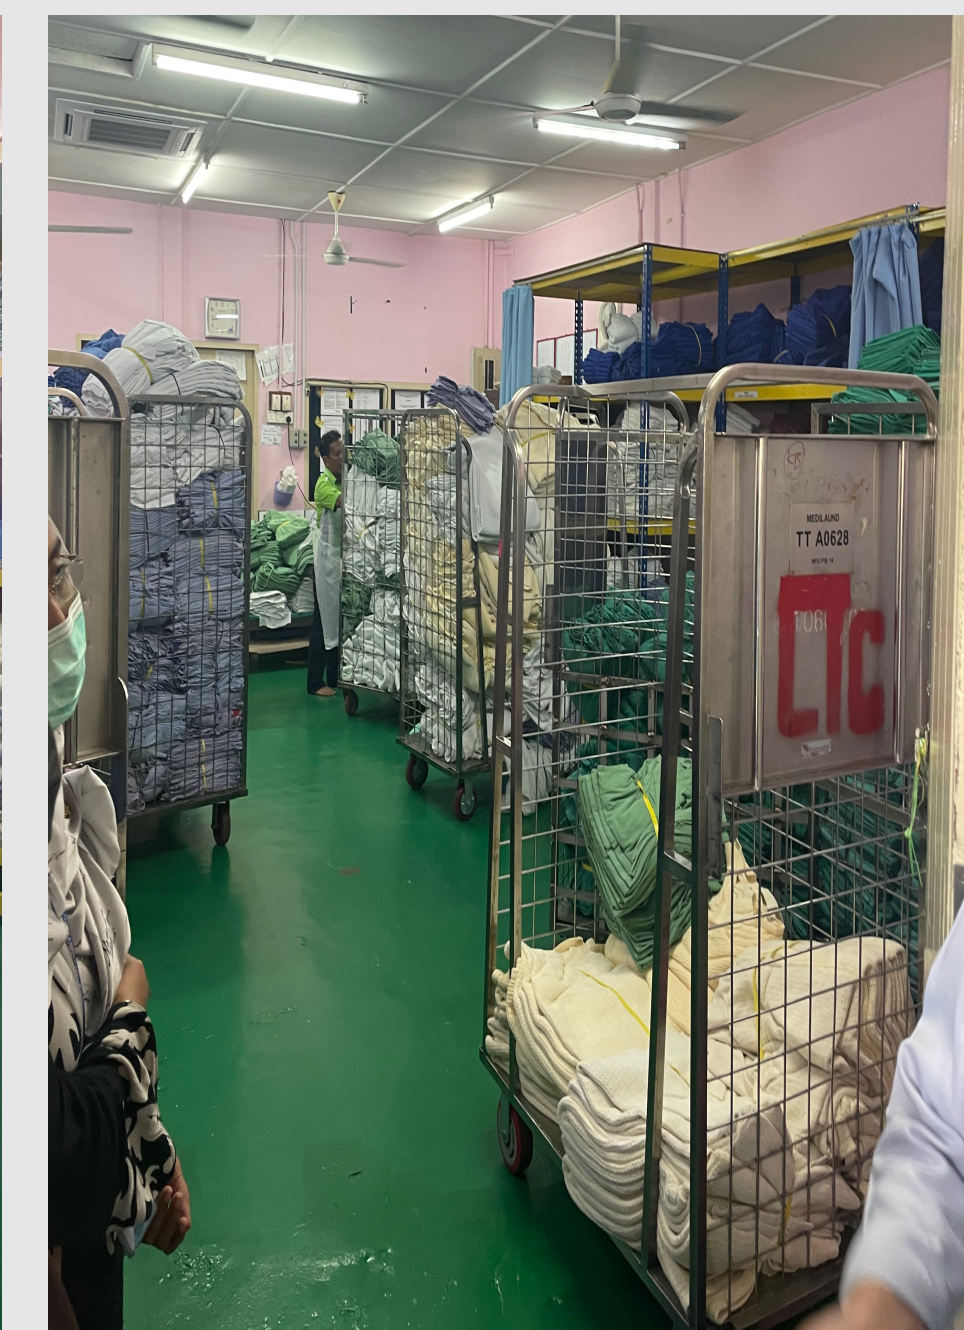
Observation showed several non-compliance issues regarding floor plan, ventilation, rack, first in first out (FIFO) practice, cleaning schedule and trolley were detected (figure 4). A microbiologic surveillance study was conducted on 31st July 2023 at main linen storage showed present of *Monilia sp*, *Aspergillus sp*, and *Penicillium sp* as in figure 1. Renovation was done. Post renovation surveillance showed fewer CFU on the agar plate (figure 2). Temperature post renovation was 24.5 Celsius and humidity was 52.0 % which is optimum for linen storage.

Figure 4. Linen store before renovation

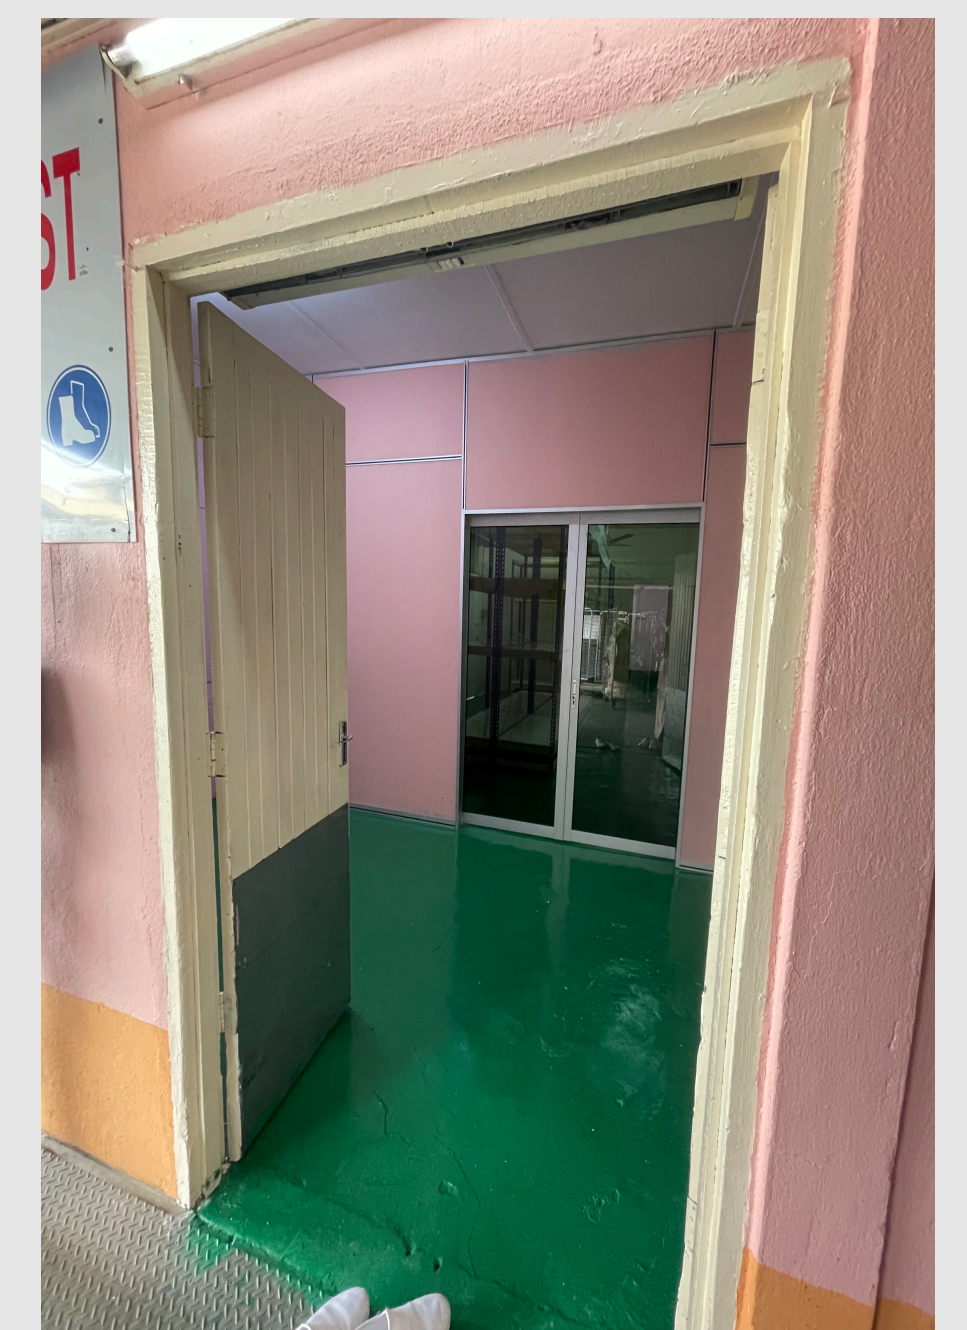
Figure 5. Linen store post renovation – anteroom

At 33% of hospitals, the linen were visibly unclean². The linen storage should be a clean area category. *Aspergillus sp* is the commonest fungal contaminated linen. Significant amount of spore can cause disease to patient especially in immunosuppression patients³. The new floor plan was done, no trolley from outside can go inside, sliding door and anteroom were built (figure 5). New rack with easy clean base were restore. FIFO signage was put on the rack to ensure there is always new linen supplied to the users. Air condition functioning well, no fans. Sort, package, transport, and store clean linens in a manner that prevents risk of contamination by dust, debris, soiled linens or other soiled items. Each floor/ward should have a designated room for sorting and storing clean linens⁴. Continuous monitoring was done monthly to ensure the linen being stored according to written policy by Ministry of Health and the results were satisfactory⁵.
